Bending Strength Test and Evaluation of a Transtibial Prosthetic Socket Fabricated by Selective Laser Sintering

Thesis

Master of Science in Engineering

The University of Texas at Austin

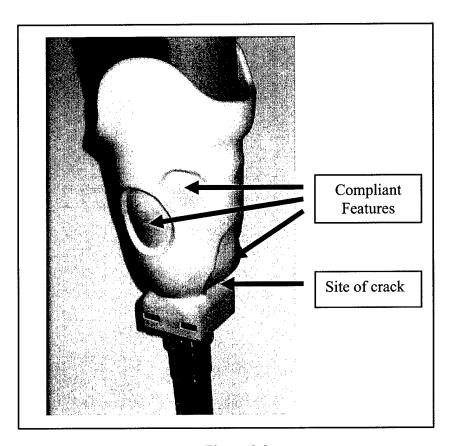
Specifically, a prototype of the design was manufactured from DuraformTM and fitted for a user in an experimental study. The wearer stepped off of a bus and down to a curb and shortly thereafter discovered a large crack at the bottom of the socket below the distal end compliant feature as noted in Figure 2.3.

Fortunately, the failure was not catastrophic at the moment the individual stepped onto the curb, as this may have caused an injury. However, the potential for injury was obvious and the incident certainly demonstrated inadequate load bearing properties for this type of use with the current socket design. In order to begin offering the SLS sockets on a large scale, prosthetists need reliable failure data and safe load limits for normal use. Additionally, analytically determined design improvements must be explored to take advantage of the full potential of SLS technology and DuraformTM's beneficial properties.

Figure 2.3 Socket to be tested with site of prototype's crack indicated.

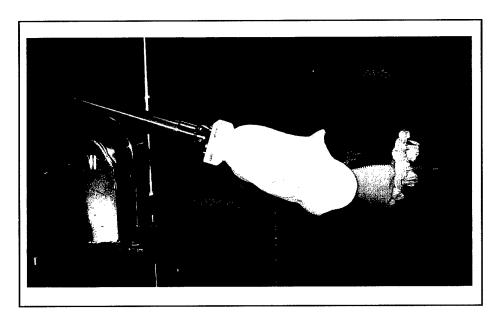
Figure 3.7

was initially constrained using a molded urethane form inside a commonlyused rubber foam padding sock. However, the natural compression due to gravity that holds the remaining limb inside the socket during normal gait was absent in this configuration. The sock's low friction characteristics allowed it to slip with a minimally applied force to the pylon. (See Figure 3.7.)

Photograph of socket slipping off of padded sock during test.

In order to overcome this obstacle, the urethane form and padded sock were replaced with a fill of RockiteTM plaster with casting sand at the base of the socket to minimize alterations to the DuraformTM characteristics. While this was not ideal because the plaster changed the DuraformTM response where the two came in contact, it was the best solution for the

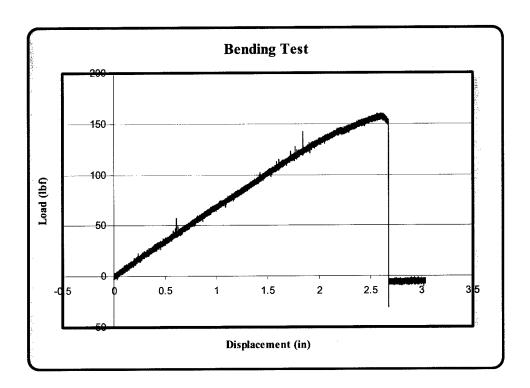
Figure 3.10
Graph indicating applied load and displacement of free end of socket assembly.

As shown in Figure 3.10, the maximum load reached before the socket failed was 159.929 lbf. The displacement at this load was 2.567 in and the maximum displacement was 2.677 in before failure occurred. The socket tested is sized for an individual of approximately 140 lb.

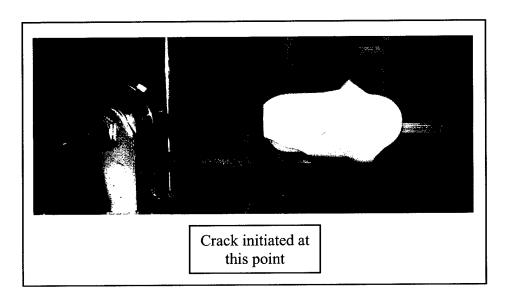
By visual inspection, the crack began at the bottom center of the distal end compliant feature, just at the point where the feature touches the socket base. (See Figures 3.11 and 3.12.) It spread quickly from there and

the entire base snapped off within a few seconds of the appearance of the initial crack. The break was clean and no pieces of recognizable size shattered or splintered from the socket or the base.

Figure 3.11
Photograph of failed socket with point of crack initiation indicated.

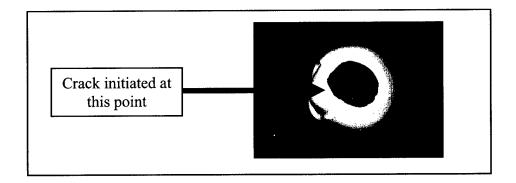
Figure 3.12

Broken socket viewed from the distal end with casting sand visible.

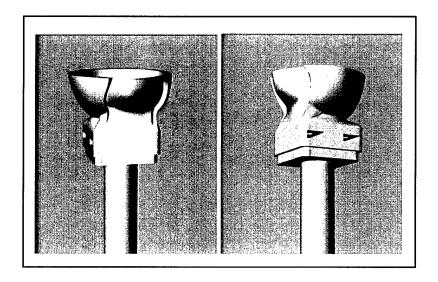
Figure 5.2 Modified socket design.

The first step towards an improved design involves modifying the thickness of the socket wall at the compliance feature as this is where the socket failed and where the FEA indicated the greatest stress concentrations. It is not necessary to maintain a uniform thickness throughout the feature and a plausible solution would be to add filleting in the high stress region. Additional thickness is needed along the curve of the feature to avoid geometric discontinuities which create stress focal points. Ideally, this would equate to a larger force needed to reach the maximum stress value found in this analysis. An initial suggestion for this type of improvement is shown in Figure 5.2.

The most effective approach would involve developing several prototypes of increasing thickness that push the limits of compromise with the compliant feature and aesthetic considerations. The bending test (either the one designed in this work or an improved version) and FEA should then be employed to determine which revised design returns the greatest increase in the failure load with the fewest drawbacks.
